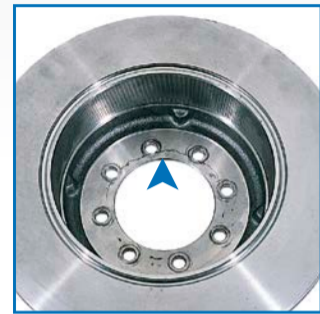
- APPEARANCE** Hub contact surface distortion, and/or cracking around the fitment holes
- CAUSE** Tightening sequence incorrect. Insufficient tightening torque used
- EFFECT** Vibration particularly on initial brake applications
- REMEDY** Replace the discs and adhere to both correct fitment sequence and manufacturer's recommended torque settings

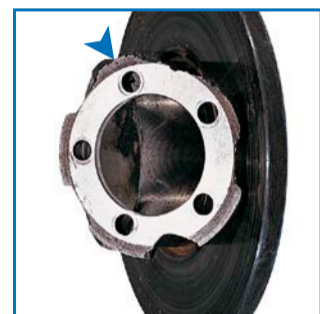
- APPEARANCE** Hub contact surface is detached or distorted
- CAUSE** Excessive tightening and failure to observe manufacturer's recommended torque and sequence during tightening
- EFFECT** Detachment of disc contact surface. Complete brake failure
- REMEDY** Full inspection of braking system and associated components. Replace any failed components and fit new discs observing manufacturer's recommended torque and sequence during tightening

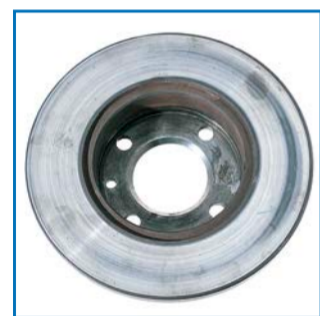
- APPEARANCE** Blue spots, darker colour of some disc areas. Evidence of localised overheating
- CAUSE** Excessive hub run-out. Uneven disc-to-pad contact generates excessive oscillation which in turn leads to localised heat generation – subsequently discolouration (blueing)
- EFFECT** Progressively increasing noise and vibration
- REMEDY** Correct the wheel hub run-out and ensure that this falls within the correct tolerances

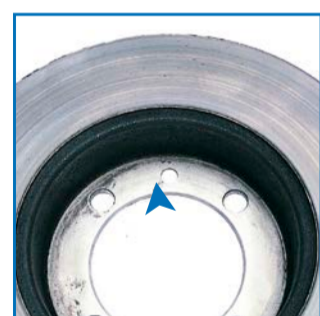
- APPEARANCE** Distortion of the hub contact surface and/or cracking around it
- CAUSE** Overly severe tightening torque used on the positioning screw
- EFFECT** Vibrations experienced from initial brake applications onwards
- REMEDY** Replace the discs avoiding excessive tightening torque. Positioning screws are only intended to ensure that discs are positioned correctly

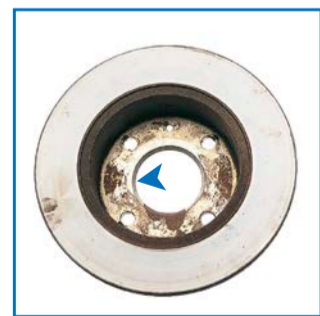
- APPEARANCE** Dirt and/or rust on hub surface
- CAUSE** Contamination on the hub surface can lead to misalignment during mounting leading to irregular contact between pad and disc surfaces and uneven wear of the disc
- EFFECT** Disc Thickness Variation which leads to oscillation of the disc surface resulting in noise and vibration. The effect becomes progressively greater with use
- REMEDY** Remove the disc and carefully clean the surfaces of wheel hub and disc, eliminating rust and other debris. Check that the support surface is neither distorted nor damaged. Replace discs observing manufacturer's recommended torque and sequence during tightening

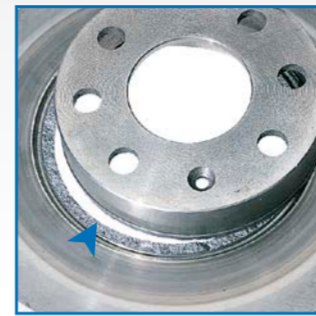
- APPEARANCE** Detachment of the disc hat from the braking surface
- CAUSE** Mechanical stress through misalignment. Incorrect assembly or positioning of the caliper and disc results in ongoing asymmetrical wear of the braking surface, eventually causing detachment
- EFFECT** Initially loud noise and vibration during braking with complete mechanical failure after detachment
- REMEDY** Full inspection of braking system and associated components. Replace any failed components and fit new discs observing manufacturer's recommended torque and sequence during tightening. Before fitting discs check the alignment and assembly of the caliper body on the axle

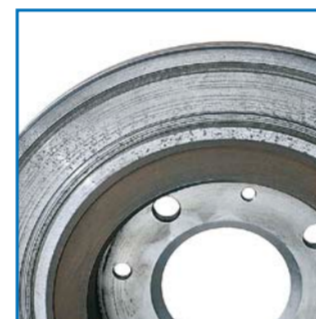
- APPEARANCE** Grooving on the disc
- CAUSE** The deep grooves are caused by loose abrasive particles between the pads and disc. Foreign debris may enter from outside the brake system (road, dirt, water) or from poorly mixed friction material
- EFFECT** Noise during braking and normal running, and lower brake efficiency due to reduced braking contact surface
- SOLUTION** Replace pads and discs

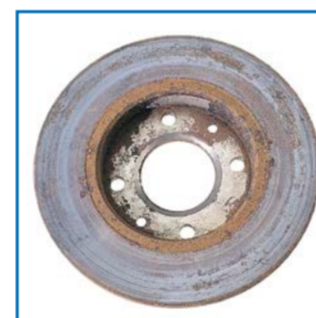
- APPEARANCE** Disc surface contamination – glazing and/or dark spots
- CAUSE** Friction material deposits have transferred to the disc surface. This usually occurs where poor quality brake pads have been fitted
- EFFECT** Vibration, poor braking efficiency and hard pedal
- SOLUTION** Only install good quality brake pads with friction material suited to the brake and vehicle

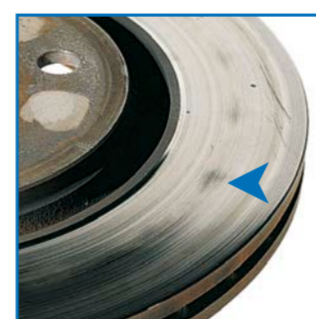
- APPEARANCE** Uneven wear of braking surfaces. Blue spots in the center of braking surface. Possible appearance of cracks
- CAUSE** Incorrect assembly of the caliper and/or pads can result in the pads being at differing angles to the disc, each side wearing at altered rates. The blue spots are generated by severe localised overheating where the friction contact occurs
- EFFECT** Gradual onset of vibrations, due to heat spots. Probable reduction of brake efficiency
- SOLUTION** Check and, if necessary, repair the caliper. Replace pads, checking type and shape are correct for application

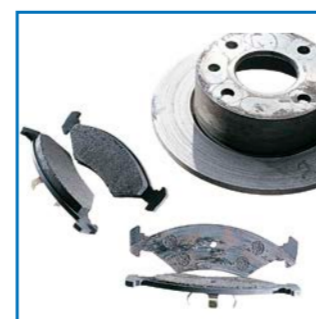
- APPEARANCE** Uneven wear of brake pads. Major wear on one pad with minimal wear on the opposing side
- CAUSE** Caliper seizure. One brake pad is in constant contact with the disc causing the pad to wear down to the metal backing plate. The side of the disc in contact with the backing plate becomes badly scored, while the other side of the disc and the other pad are practically new
- EFFECT** Ongoing grinding noise, vibration and low braking efficiency. Possible unbalanced braking action with vehicle pulling to one side
- SOLUTION** Caliper needs to be checked, replaced or repaired. Replace brake pads and discs as necessary

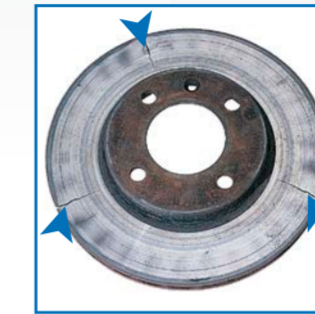
- APPEARANCE** Radial fractures/blue spots corresponding to the venting frames
- CAUSE** The blue spots are symptomatic of rising cracks. These are caused by metallurgical change in the surface material making it hard and brittle. This is typical of overloading the brakes beyond normal design limits. This could result from intensive or unusual brake use e.g. aggressive driving or excessive payload
- EFFECT** Brake fade/reduced brake performance, noise, vibrations
- SOLUTION** Replace the discs, avoid abuse of the brake system and make more efficient use of the engine/gears to aid speed reduction

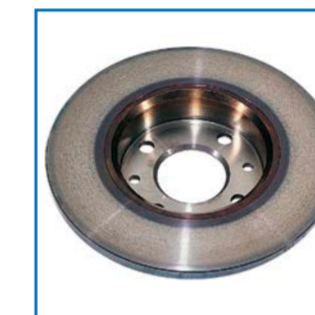
- APPEARANCE** Discs show colouring of varying intensity and shades (blue, violet, golden)
- CAUSE** Poor bedding-in. It is normal on new installations to experience slight variations on the surface between the pad and disc. If not properly bedded, the surfaces where friction occurs become overheated leading to a metallurgical change on the friction surface
- EFFECT** Poor brake efficiency due to decreased friction. Vibrations can occur which may worsen over the life of the pad and disc
- SOLUTION** Replace the discs and respect the correct bedding procedure, i.e. moderate use of the brake during the first 200 kilometres

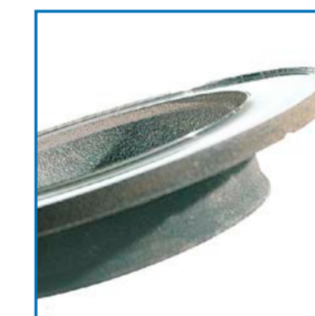
- APPEARANCE** Excessive wear. Disc thickness is lower than manufacturer's recommended 'Minimum Thickness'
- CAUSE** Discs were not checked regularly or changed at the correct point
- EFFECT** Performance decrease, vibration and excessive noise while braking
- SOLUTION** Full inspection of braking system and associated components. Replace any failed components and fit new discs observing manufacturer's recommended torque and sequence during tightening. Ensure future checking and periodic maintenance

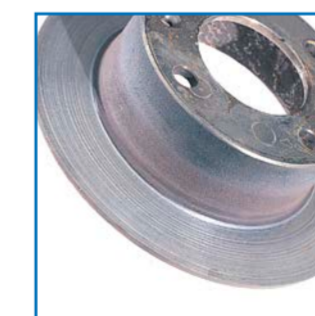
- APPEARANCE** Disc heavily worn with surface grooves
- CAUSE** Excessive or complete brake pad wear results the brake pad backing plate contacting the disc (metal to metal) damaging the disc surface
- EFFECT** Very low braking efficiency/increased stopping distances and grinding noise
- SOLUTION** Replace discs and pads. Where applicable, confirm the pad wear warning indicator circuit is working correctly

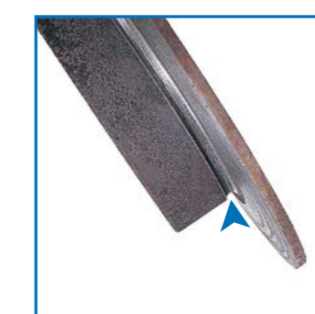
- APPEARANCE** Deep grooving between hat and disc surface
- CAUSE** Excessive pad and disc wear may lead to movement of the backing plate within the caliper. In this case, the backplate of the worn pad has come loose from its seat within the caliper causing grooving between hat and disc surface
- EFFECT** Very low braking efficiency with a long pedal stroke and heavy noise
- SOLUTION** Replace discs and pads. Check and, if necessary, repair the caliper
